**Flood Control Project Maintenance  
Levee Inspections**

**Fall 2010 Levee Maintenance Deficiency Summary Report**

**Reclamation District No. 0563 Tyler Island**

**Levee Inspection Report By Mile - Fall 2010**

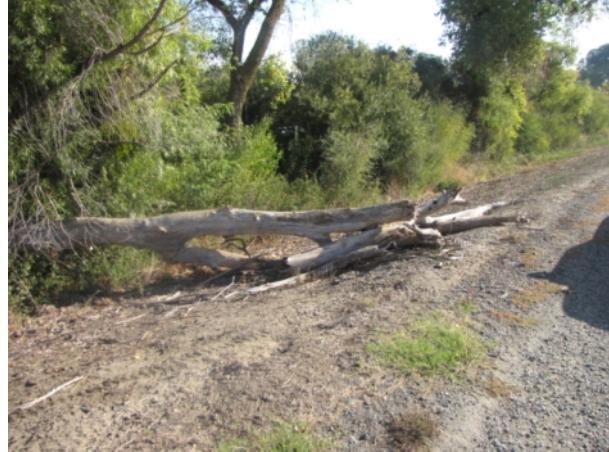
Looking north at down tree on waterside slope.

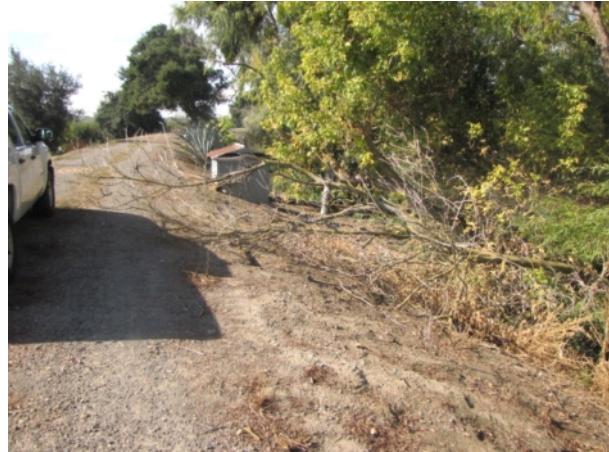
Levee Mile Report Line	14
Start Levee Mile	1.42
End Levee Mile	1.42
Location	Water Side
Category	Earthen Levee
Item	Encroachments

14	1.42	1.42	Earthen Levee	Encroachments	WS M		Tree or limb Inspector Comments: Down tree along waterside slope.	38.224367 °	38.224367 °	19 -121.534165 ° -121.534165 ° Y
15	1.44	1.48	Earthen Levee	Vegetation	WS M		Remove the wild growth other than native grasses from the levee slopes. Inspector Comments: Remove century plant from waterward shoulder.	38.224280 °	38.224000 °	6 -121.534377 ° -121.535038 ° Y
16	1.45	1.45	Earthen Levee	Encroachments	WS M		Tree or limb Inspector Comments: Down tree across waterside slope.	38.224147 °	38.224147 °	24 -121.534610 ° -121.534610 ° Y
17	1.46	1.46	Earthen Levee	Encroachments	WS M		Tree or limb Inspector Comments: Tree limb down.	38.224092 °	38.224092 °	8 -121.534717 ° -121.534717 ° Y
18	1.47	1.47	Earthen Levee	Trim / Thin Trees	LS M		Trim trees to at least five feet above ground level.	38.224072 °	38.224072 °	30 -121.534827 ° -121.534827 °

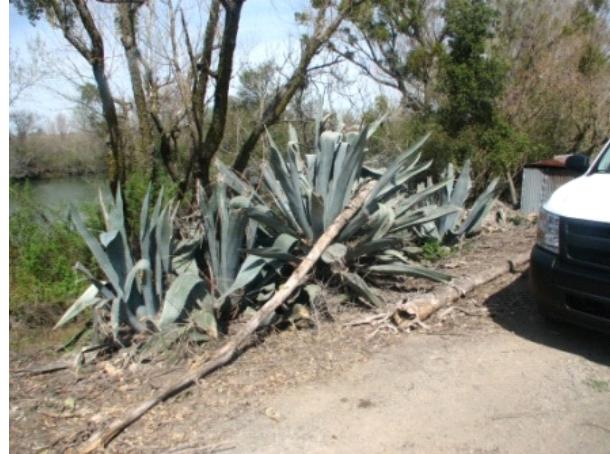
Levee Mile Report Line	15
Start Levee Mile	1.44
End Levee Mile	1.48
Location	Water Side
Category	Earthen Levee
Item	Vegetation
Century plant on waterward shoulder at LM 1.42	
richard_f_20100921_162.jpg

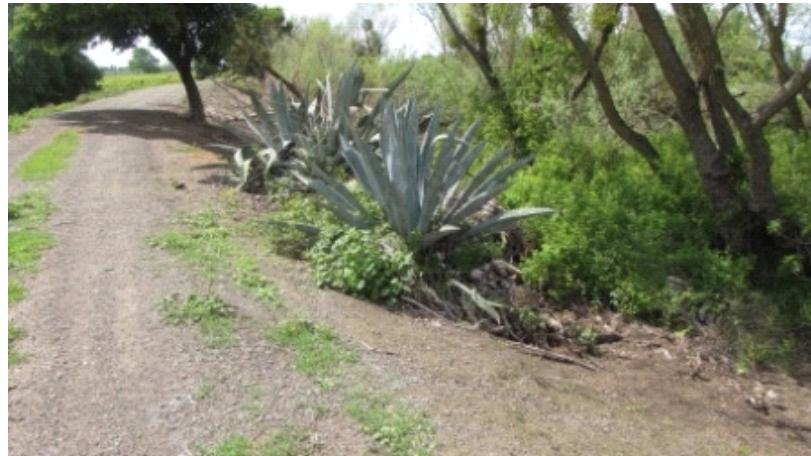
Levee Mile Report Line	15
Start Levee Mile	1.44
End Levee Mile	1.48
Location	Water Side
Category	Earthen Levee
Item	Vegetation
Looking upstream at updated century plant on waterside shoulder slope.	
richard_f_20100921_163.jpg

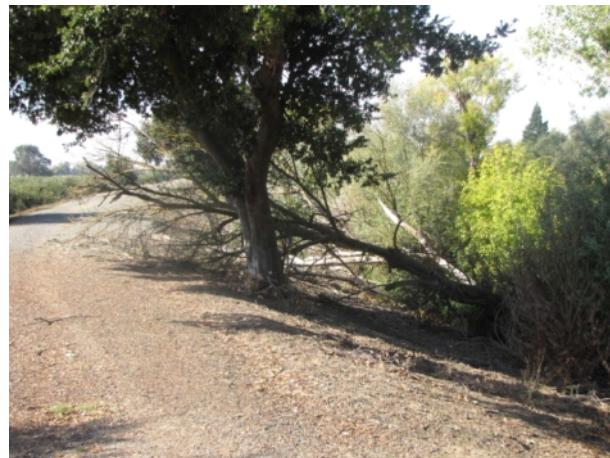
Levee Mile Report Line	16
Start Levee Mile	1.45
End Levee Mile	1.45
Location	Water Side
Category	Earthen Levee
Item	Encroachments
Looking south at down tree on waterside slope.	
richard_f_20101029_360.jpg

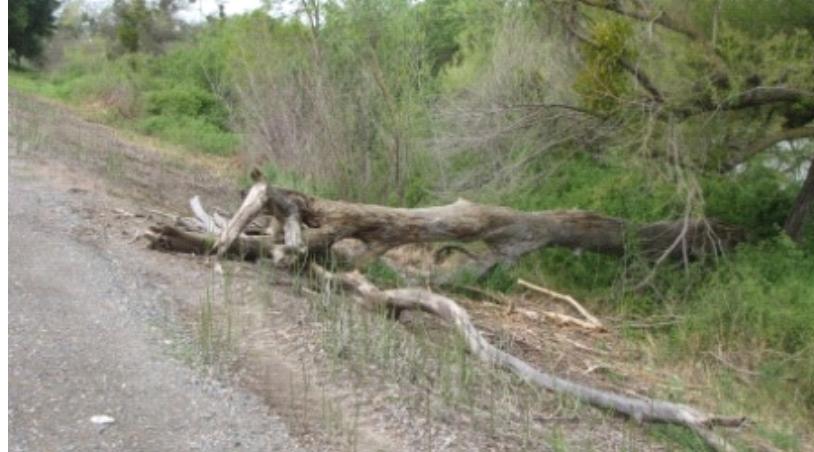
Levee Mile Report Line	17
Start Levee Mile	1.46
End Levee Mile	1.46
Location	Water Side
Category	Earthen Levee
Item	Encroachments
Looking at tree limb on waterside slope.	
richard_f_20100921_164.jpg

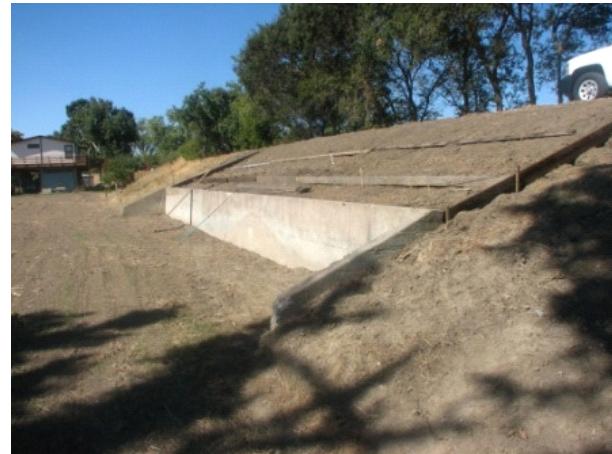
Levee Mile Report Line	21
Start Levee Mile	1.86
End Levee Mile	1.86
Location	Land Side
Category	Earthen Levee
Item	Encroachments
Unauthorized retaining wall on landside toe.	
richard_f_20100921_190.jpg

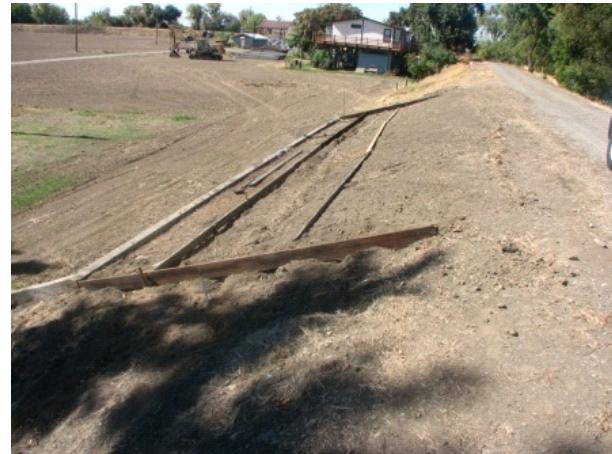
Levee Mile Report Line	21
Start Levee Mile	1.86
End Levee Mile	1.86
Location	Land Side
Category	Earthen Levee
Item	Encroachments
Looking southeast at top of retaining wall.	
richard_f_20100921_191.jpg

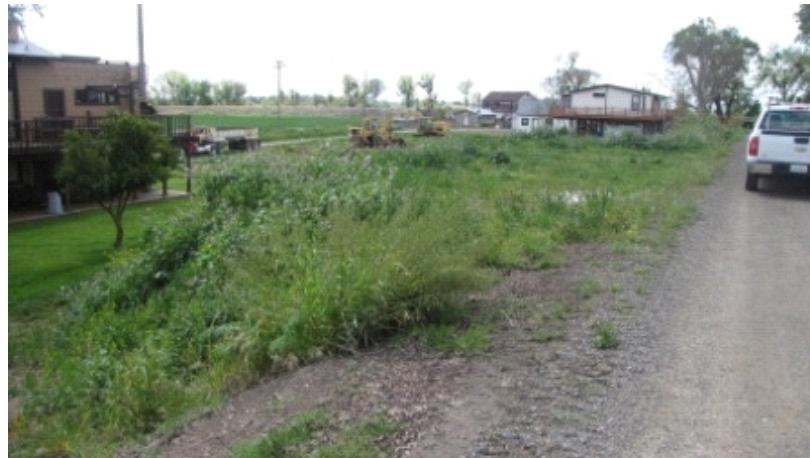
Levee Mile Report Line	21
Start Levee Mile	1.86
End Levee Mile	1.86
Location	Land Side
Category	Earthen Levee
Item	Encroachments
Looking southeast at earthen pad on landside shoulder covering retaining wall.	
richard_f_20100921_192.jpg

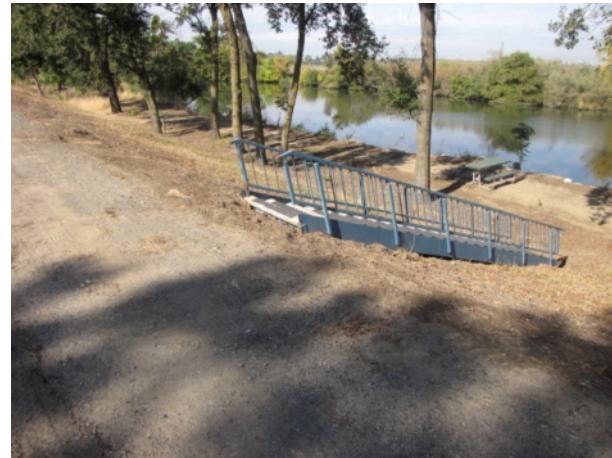
Levee Mile Report Line	21
Start Levee Mile	1.86
End Levee Mile	1.86
Location	Land Side
Category	Earthen Levee
Item	Encroachments
Looking west at metal stairs on waterside slope.	
richard_f_20101029_361.jpg

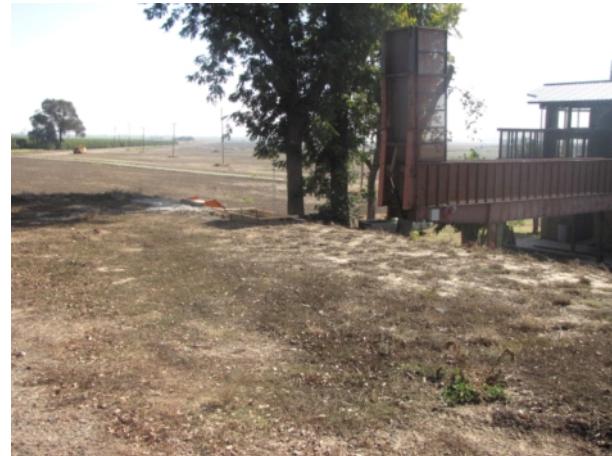
Levee Mile Report Line	21
Start Levee Mile	1.86
End Levee Mile	1.86
Location	Land Side
Category	Earthen Levee
Item	Encroachments
Looking northeast metal walkway on landside of levee.	
richard_f_20101029_362.jpg

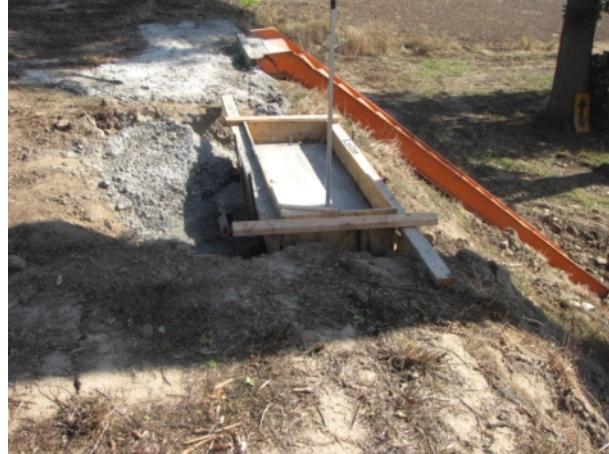
Levee Mile Report Line	21
Start Levee Mile	1.86
End Levee Mile	1.86
Location	Land Side
Category	Earthen Levee
Item	Encroachments
Looking north at deadman for metal walkway on earthen pad on landside shoulder.	
richard_f_20101029_363.jpg

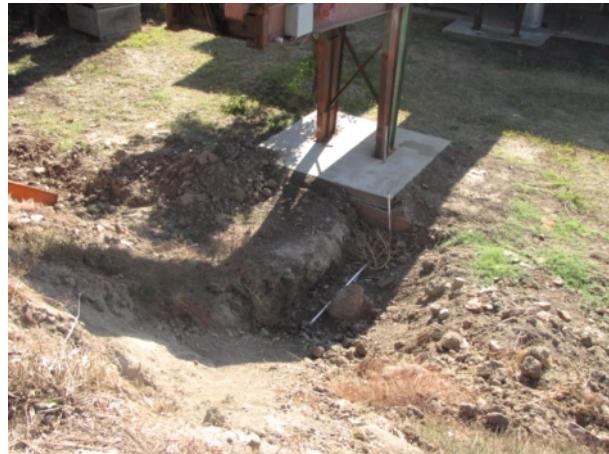
Levee Mile Report Line	21
Start Levee Mile	1.86
End Levee Mile	1.86
Location	Land Side
Category	Earthen Levee
Item	Encroachments
Looking east at electrical conduit in trench on landside toe and concrete pad for walkway.	
richard_f_20101029_364.jpg

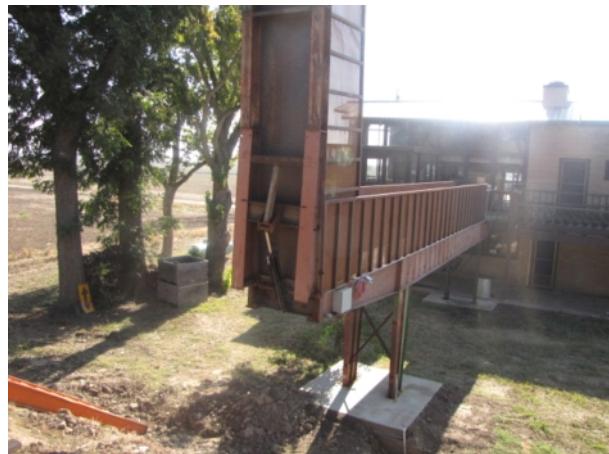
Levee Mile Report Line	21
Start Levee Mile	1.86
End Levee Mile	1.86
Location	Land Side
Category	Earthen Levee
Item	Encroachments
Looking east at metal walkway on landside.	
richard_f_20101029_365.jpg

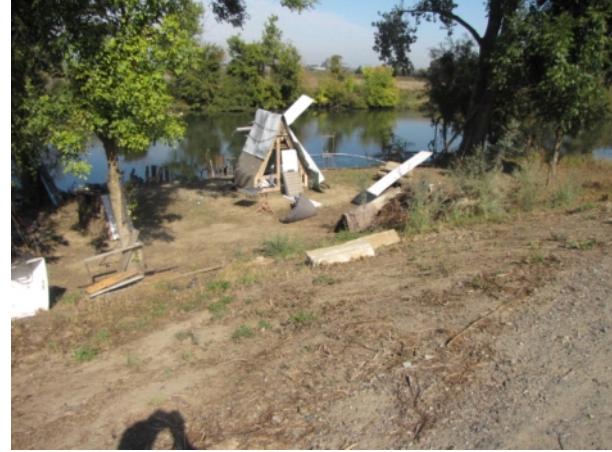
Levee Mile Report Line	22
Start Levee Mile	1.94
End Levee Mile	1.94
Location	Water Side
Category	Earthen Levee
Item	Encroachments
Looking northwest at shed as of October 2010	
richard_f_20101029_368.jpg

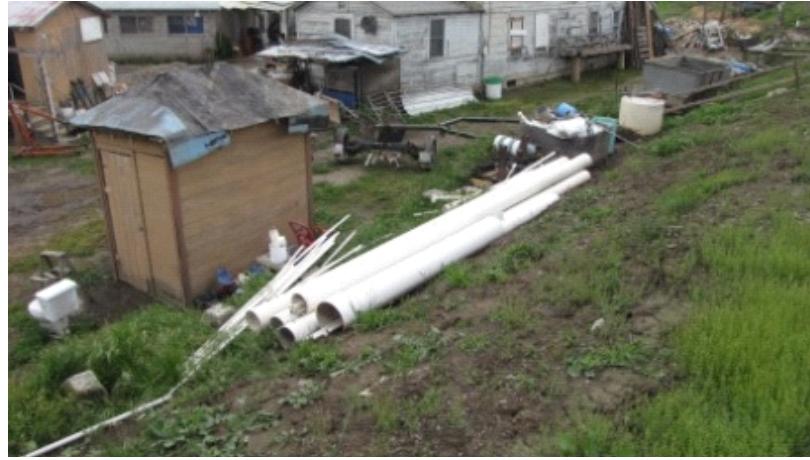
Levee Mile Report Line	23
Start Levee Mile	1.96
End Levee Mile	1.98
Location	Land Side
Category	Earthen Levee
Item	Encroachments
Looking southeast at material and equipment on landside slope and toe.	
richard_f_20100921_165.jpg

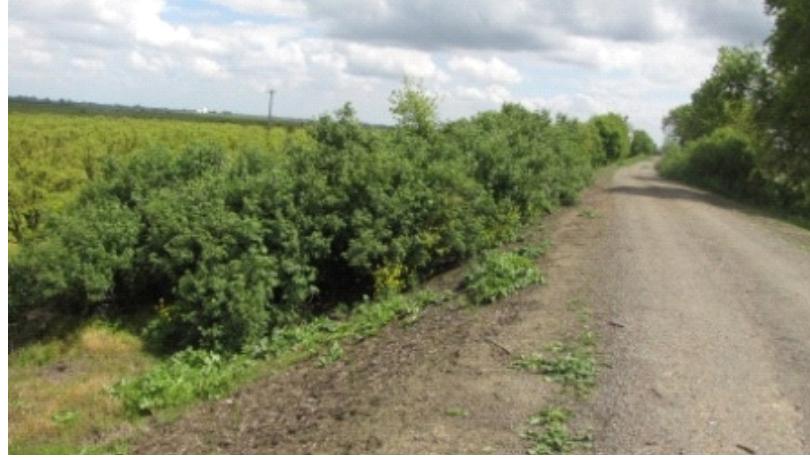
Levee Mile Report Line	27
Start Levee Mile	2.44
End Levee Mile	2.45
Location	Land Side
Category	Earthen Levee
Item	Vegetation
Looking southeast at elderberry on the landside slope and toe.	
richard_f_20100921_166.jpg

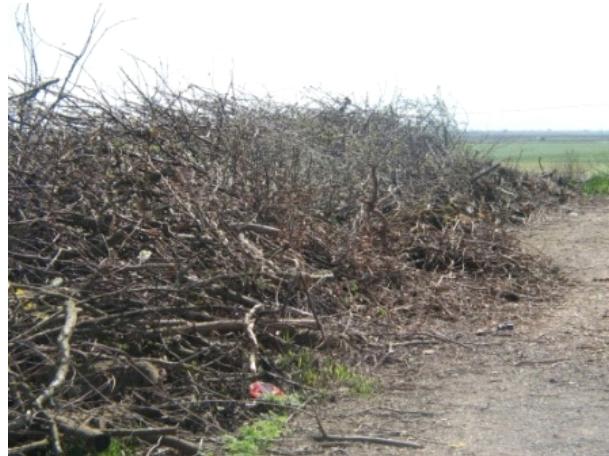
Levee Mile Report Line	33
Start Levee Mile	2.94
End Levee Mile	2.94
Location	Land Side
Category	Earthen Levee
Item	Encroachments
Prunings on landward shoulder from LM 2.93 to 2.95	
richard_f_20100921_168.jpg

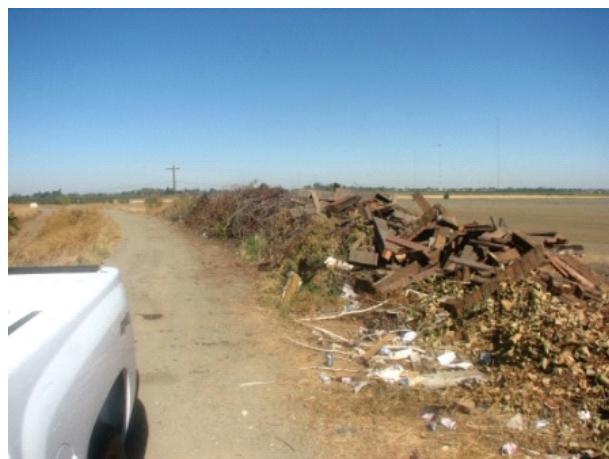
Levee Mile Report Line	33
Start Levee Mile	2.94
End Levee Mile	2.94
Location	Land Side
Category	Earthen Levee
Item	Encroachments
View looking upstream at pruning pile.	
richard_f_20100921_169.jpg

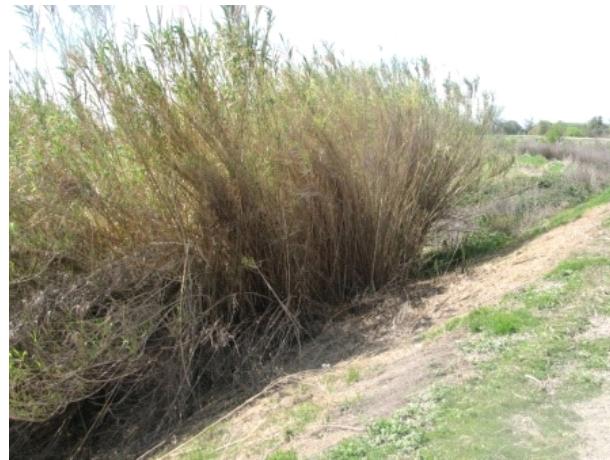
Levee Mile Report Line	35
Start Levee Mile	3.06
End Levee Mile	3.12
Location	Land Side
Category	Earthen Levee
Item	Vegetation
Bamboo at landward toe at LM 3.05	
richard_f_20100921_170.jpg

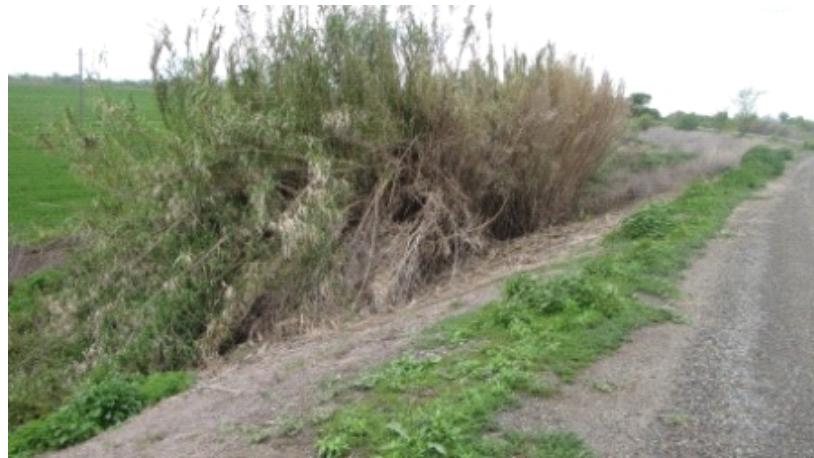
Levee Mile Report Line	35
Start Levee Mile	3.06
End Levee Mile	3.12
Location	Land Side
Category	Earthen Levee
Item	Vegetation
Looking southeast at updated view of bamboo on landside slope and toe.	
richard_f_20100921_171.jpg

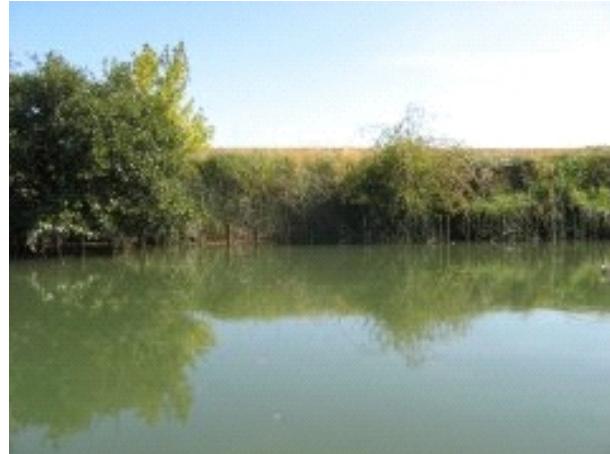
Levee Mile Report Line	40
Start Levee Mile	4.00
End Levee Mile	4.02
Location	Water Side
Category	Supplemental
Item	USACE Erosion Survey
2009: 15 ft berm, 1.5:1 slope, no stability issues, clays and silts, 3.68 ft/s [2009 SiteID:GEO_8-3_L]	
richard_f_20100921_177.JPG

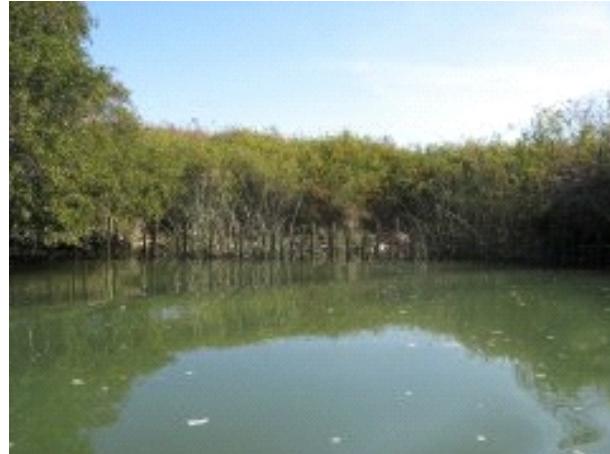
Levee Mile Report Line	41
Start Levee Mile	5.12
End Levee Mile	5.16
Location	Water Side
Category	Supplemental
Item	USACE Erosion Survey
2009: no berm, 2:1 slope, no stability issues, clays and silts, 3.71 ft/s [2009 SiteID:GEO_7-2_L]	
richard_f_20100921_178.JPG

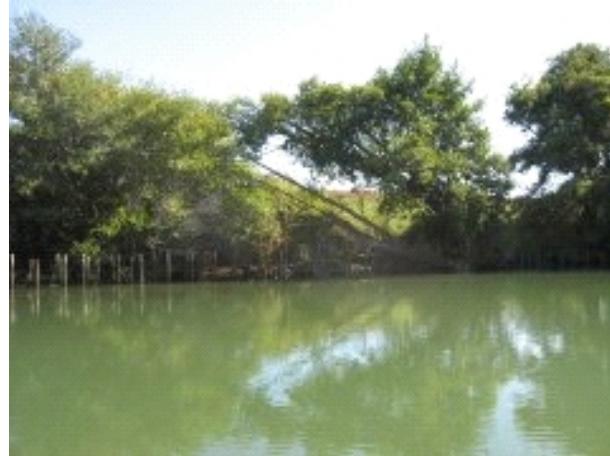
Levee Mile Report Line	42
Start Levee Mile	5.29
End Levee Mile	5.52
Location	Water Side
Category	Supplemental
Item	USACE Erosion Survey
2009: 10 ft berm, 1.5:1 slope, tree hazards and holes, clays and silts, 3.78 ft/s [2009 SiteID:GEO_6-8_L]	
richard_f_20100921_179.JPG

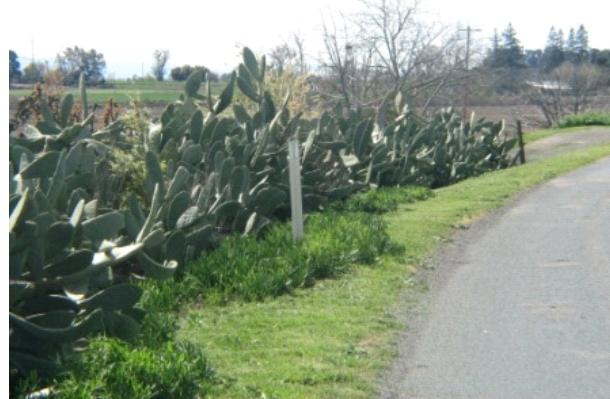
Levee Mile Report Line	46
Start Levee Mile	6.04
End Levee Mile	6.08
Location	Land Side
Category	Earthen Levee
Item	Vegetation
Large Cactus plant on landward slope from LM 6.04 to 6.08	
richard_f_20100921_172.jpg

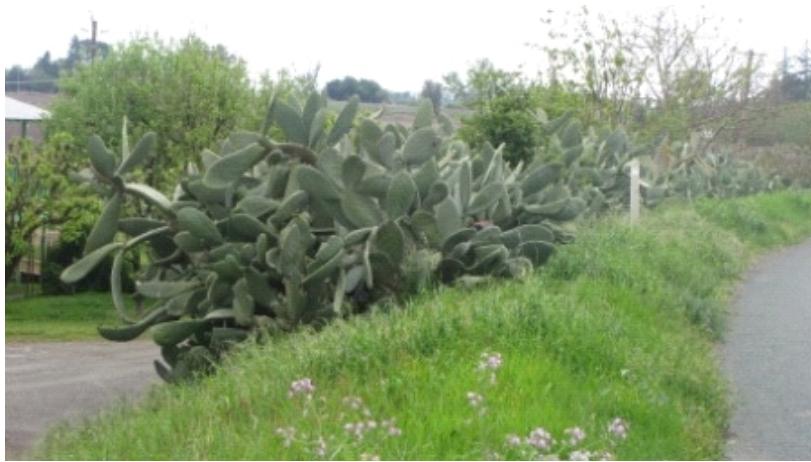
Levee Mile Report Line	46
Start Levee Mile	6.04
End Levee Mile	6.08
Location	Land Side
Category	Earthen Levee
Item	Vegetation
Looking at north end of catcus on the landside slope.	
richard_f_20100921_173.jpg

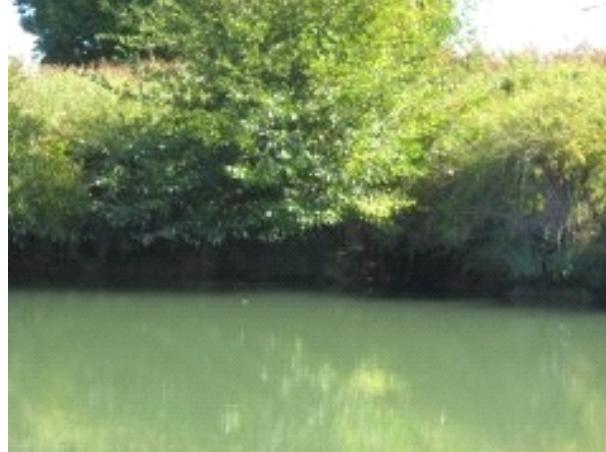
Levee Mile Report Line	47
Start Levee Mile	6.07
End Levee Mile	6.41
Location	Water Side
Category	Supplemental
Item	USACE Erosion Survey
2009: 10 ft berm, 1.5:1 slope, tree hazards, clays and silts, 3.95 ft/s [2009 SiteID:GEO_6-1_L]	
richard_f_20100921_180.JPG

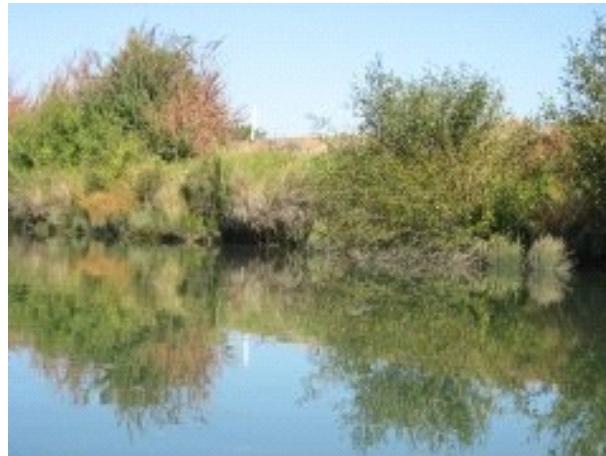
53	6.83	7.44	Supplemental USACE Erosion Survey	WS	M	Inspector Comments: 2009: 5 ft berm, 1.5:1 slope, tree hazards and holes, clays and silts, 3.95 ft/s [2009 SiteID:GEO_5-3_L]			38.176292 °	38.168006 ° 46 -121.580106 ° -121.581717 ° Y	
54	6.90	6.94	Earthen Levee	Trim / Thin Trees	LS	U	Trim trees to at least five feet above ground level.			38.175190 °	38.174610 ° 27 -121.580035 ° -121.579948 ° Y
55	7.54	7.54	Earthen Levee	Encroachments	LS	M	Garbage			38.166608 °	38.166608 ° 72 -121.582212 ° -121.582212 ° Y
56	7.54	7.54	Earthen Levee	Encroachments	WS	M	Garbage			38.166593 °	38.166593 ° 71 -121.582228 ° -121.582228 ° Y
57	7.70	7.92	Supplemental USACE Erosion Survey	WS	M	Inspector Comments: 2009: 5 ft berm, 1.5:1 slope, tree hazards, clays and silts, 3.94 ft/s [2009 SiteID:GEO_4-6_L]			38.164481 °	38.161561 ° 48 -121.583214 ° -121.584631 ° Y	
58	7.89	7.91	Earthen Levee	Vegetation	LS	M	Remove the wild growth other than native grasses from the levee slopes.			38.161825 °	38.161633 ° 29 -121.584135 ° -121.584222 °

Levee Mile Report Line	53
Start Levee Mile	6.83
End Levee Mile	7.44
Location	Water Side
Category	Supplemental
Item	USACE Erosion Survey
2009: 5 ft berm, 1.5:1 slope, tree hazards and holes, clays and silts, 3.95 ft/s [2009 SiteID:GEO_5-3_L]	
richard_f_20100921_181.JPG

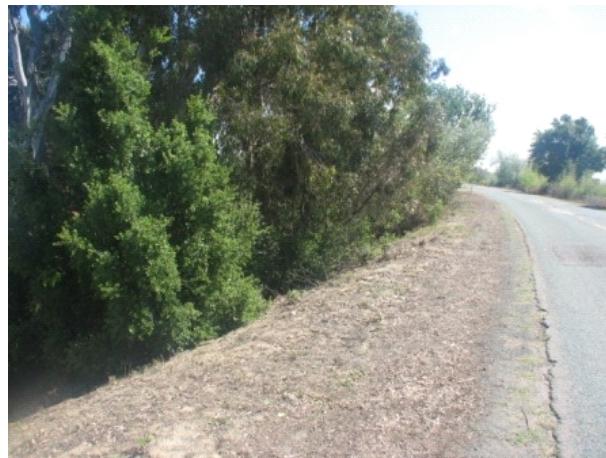
Levee Mile Report Line	54
Start Levee Mile	6.90
End Levee Mile	6.94
Location	Land Side
Category	Earthen Levee
Item	Trim / Thin Trees
Side view of dense trees along landside slope and shoulder.	
richard_f_20100921_174.jpg

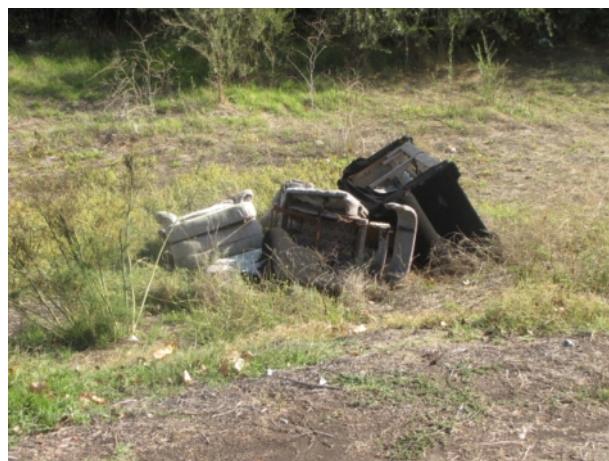
Levee Mile Report Line	55
Start Levee Mile	7.54
End Levee Mile	7.54
Location	Land Side
Category	Earthen Levee
Item	Encroachments
Looking east at garbage on landside toe.	
richard_f_20101029_372.jpg

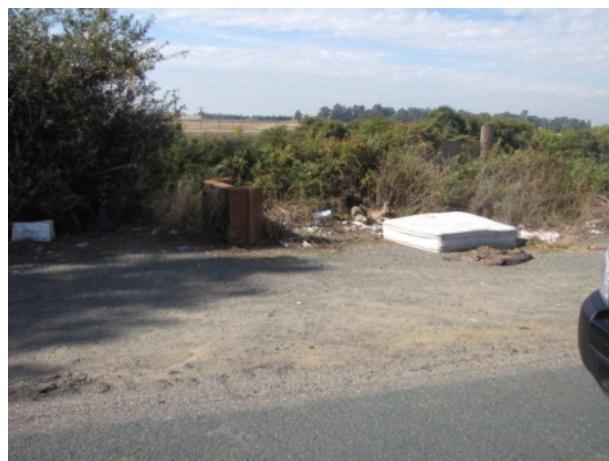
Levee Mile Report Line	56
Start Levee Mile	7.54
End Levee Mile	7.54
Location	Water Side
Category	Earthen Levee
Item	Encroachments
Looking west at garbage on waterside shoulder.	
richard_f_20101029_371.jpg

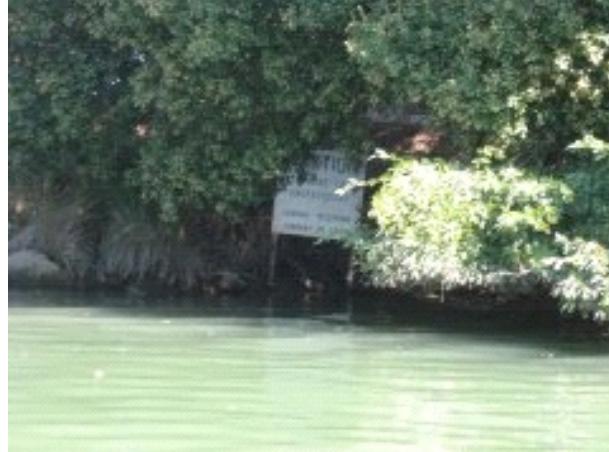
Levee Mile Report Line	57
Start Levee Mile	7.70
End Levee Mile	7.92
Location	Water Side
Category	Supplemental
Item	USACE Erosion Survey
2009: 5 ft berm, 1.5:1 slope, tree hazards, clays and silts, 3.94 ft/s [2009 SiteID:GEO_4-6_L]	
richard_f_20100921_182.JPG

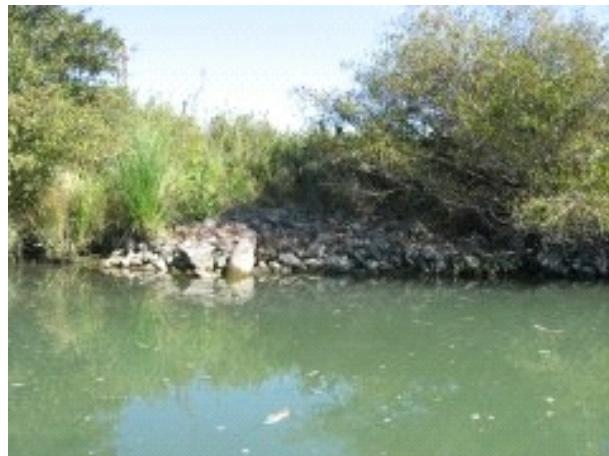
Levee Mile Report Line	60
Start Levee Mile	8.04
End Levee Mile	8.23
Location	Water Side
Category	Supplemental
Item	USACE Erosion Survey
2009: 5 ft berm, 1.5:1 slope, no stability issues, clays and silts, 4.02 ft/s [2009 SiteID:GEO_4-3_L]	
richard_f_20100921_184.JPG

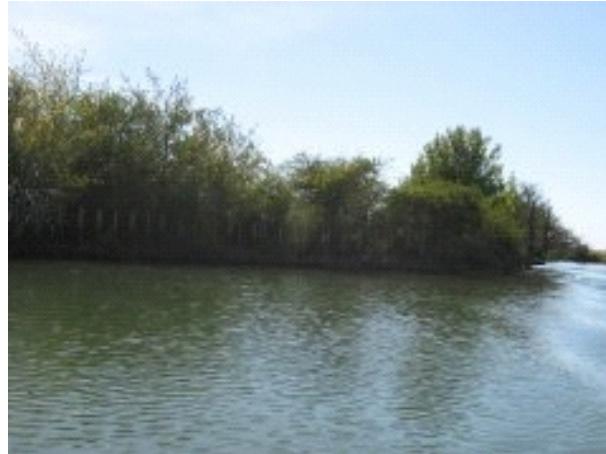
Levee Mile Report Line	62
Start Levee Mile	8.40
End Levee Mile	8.48
Location	Water Side
Category	Supplemental
Item	USACE Erosion Survey
2009: 5 ft berm, 2:1 slope, holes, sands and silts, 4.04 ft/s [2009 SiteID:GEO_3-71_L]	
richard_f_20100921_186.JPG

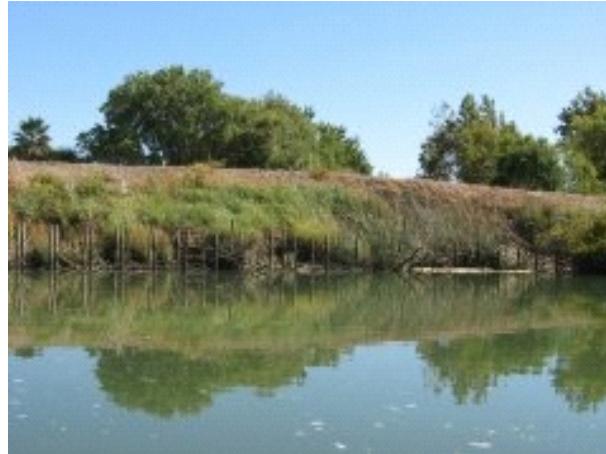
Levee Mile Report Line	63
Start Levee Mile	8.50
End Levee Mile	8.53
Location	Water Side
Category	Supplemental
Item	USACE Erosion Survey
2009: 5 ft berm, 2:1 slope, holes, sands and silts, 4.64 ft/s [2009 SiteID:GEO_3-7_L]	
richard_f_20100921_188.JPG

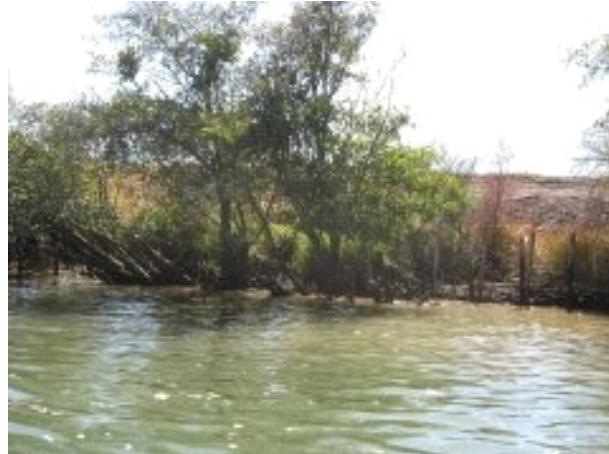
Levee Mile Report Line	69
Start Levee Mile	9.90
End Levee Mile	9.96
Location	Water Side
Category	Supplemental
Item	USACE Erosion Survey
2009: 5 ft berm, 2.5:1 slope, no stability issues, clays and silts, 3.99 ft/s [2009 SiteID:GEO_2-5_L]	
richard_f_20100921_193.JPG

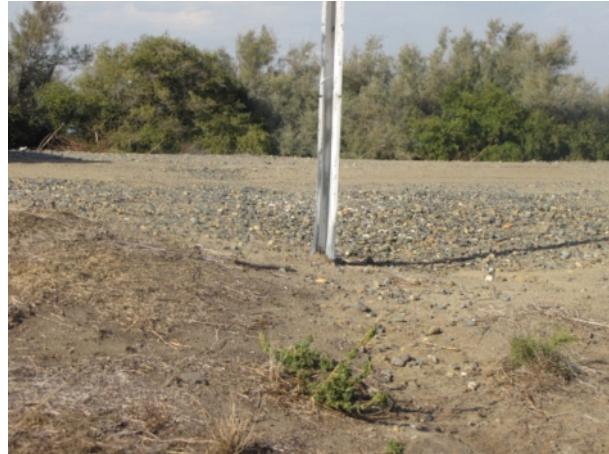
Levee Mile Report Line	71
Start Levee Mile	10.06
End Levee Mile	10.06
Location	Crown
Category	Earthen Levee
Item	Crown Surface / Depressions / Rutting
Looking west at depression on waterside shoulder from landside toe.	
richard_f_20101029_373.jpg

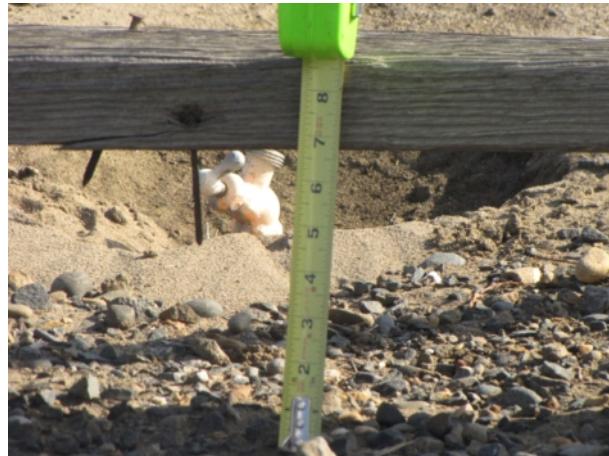
Levee Mile Report Line	71
Start Levee Mile	10.06
End Levee Mile	10.06
Location	Crown
Category	Earthen Levee
Item	Crown Surface / Depressions / Rutting
Looking east at board marking a depression greater than six inches.	
richard_f_20101029_375.jpg

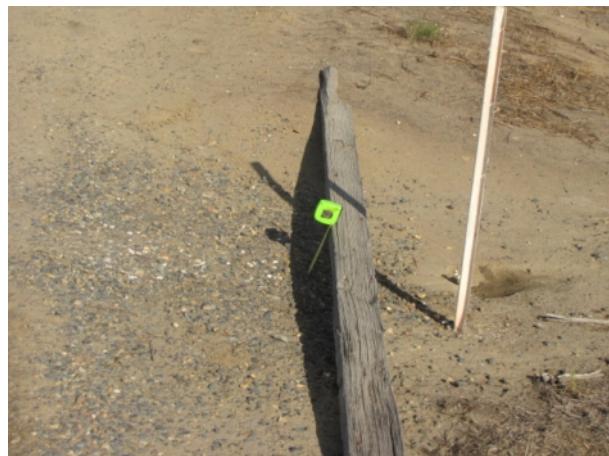
Levee Mile Report Line	71
Start Levee Mile	10.06
End Levee Mile	10.06
Location	Crown
Category	Earthen Levee
Item	Crown Surface / Depressions / Rutting
Looking north at board marking depression on landside shoulder and crown.	
richard_f_20101029_376.jpg

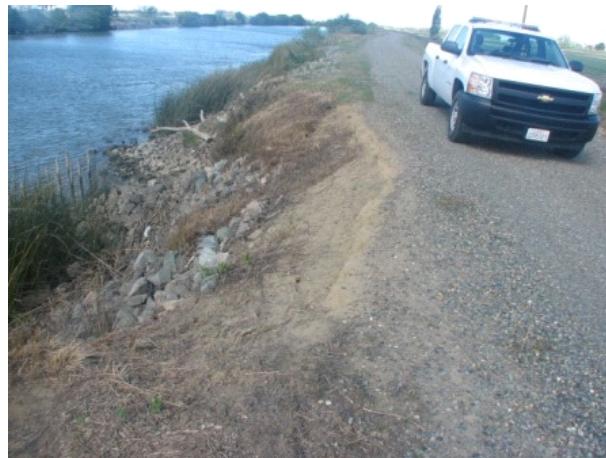
Levee Mile Report Line	73
Start Levee Mile	10.44
End Levee Mile	10.44
Location	Water Side
Category	Earthen Levee
Item	Erosion / Bank Caving
Looking downstream at erosion site on waterside slope and shoulder.	
richard_f_20100921_202.jpg

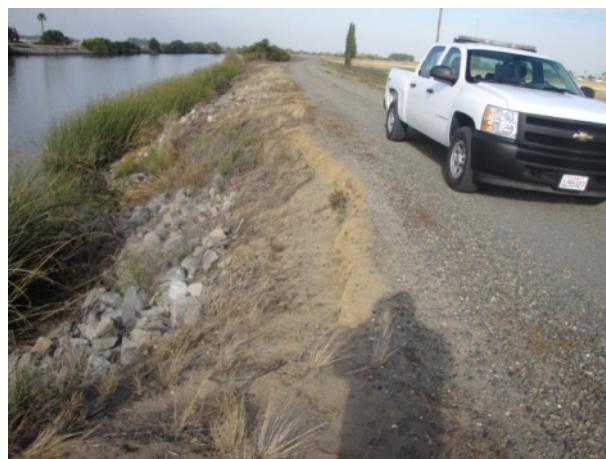
Levee Mile Report Line	73
Start Levee Mile	10.44
End Levee Mile	10.44
Location	Water Side
Category	Earthen Levee
Item	Erosion / Bank Caving
Looking north at updated picture of erosion site as of October 2010	
richard_f_20101029_377.jpg

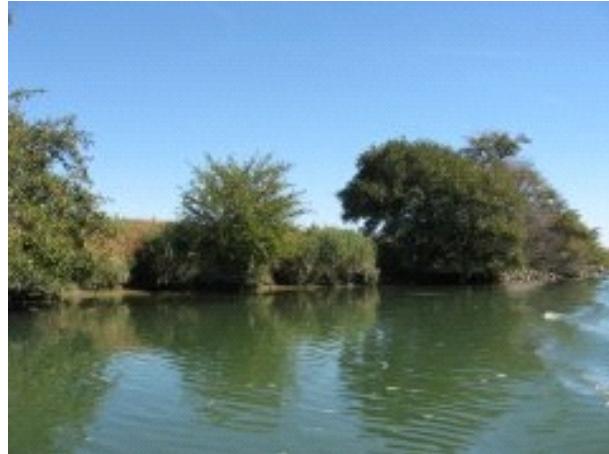
Levee Mile Report Line	74
Start Levee Mile	10.63
End Levee Mile	10.89
Location	Water Side
Category	Supplemental
Item	USACE Erosion Survey
2009: 5 ft berm, 2:1 slope, holes, clays and silts, 4.05 ft/s [2009 SiteID:GEO_1-7_L]	
richard_f_20100921_195.JPG

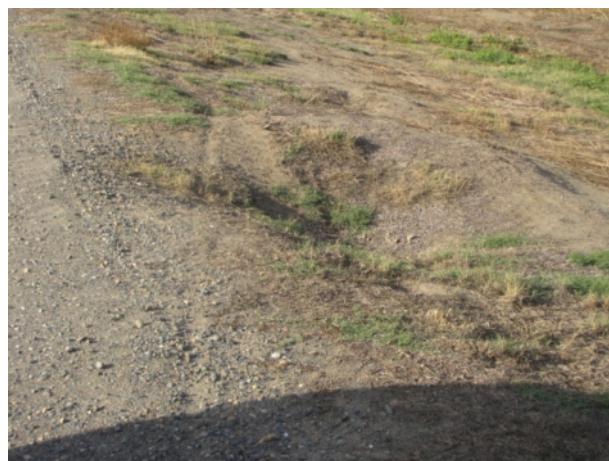
Levee Mile Report Line	75
Start Levee Mile	10.77
End Levee Mile	10.77
Location	Land Side
Category	Earthen Levee
Item	Slope Stability
Looking northeast at a depression on landside shoulder and slope above 10" irrigation pipe four feet below crown.	
richard_f_20101029_379.jpg

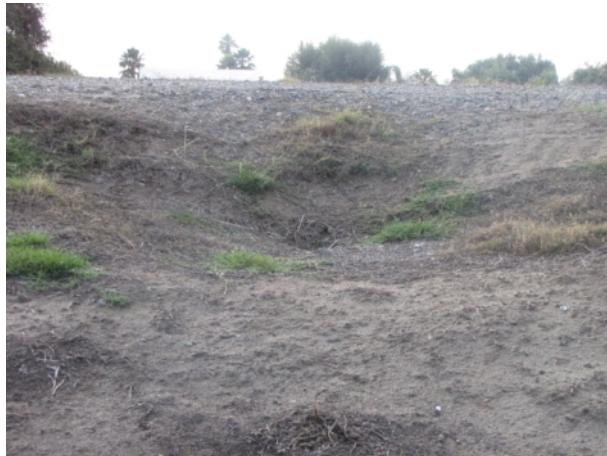
Levee Mile Report Line	75
Start Levee Mile	10.77
End Levee Mile	10.77
Location	Land Side
Category	Earthen Levee
Item	Slope Stability
Looking west at depression on landside shoulder and slope from landside toe.	
richard_f_20101029_381.jpg

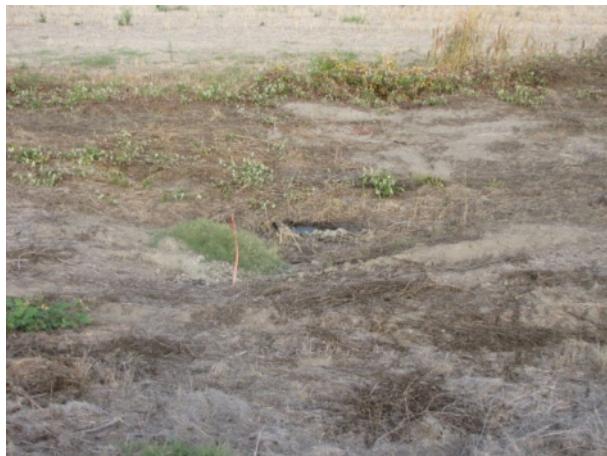
Levee Mile Report Line	75
Start Levee Mile	10.77
End Levee Mile	10.77
Location	Land Side
Category	Earthen Levee
Item	Slope Stability
Looking east at water ponding at landside toe just above 10" irrigation pipe.	
richard_f_20101029_382.jpg

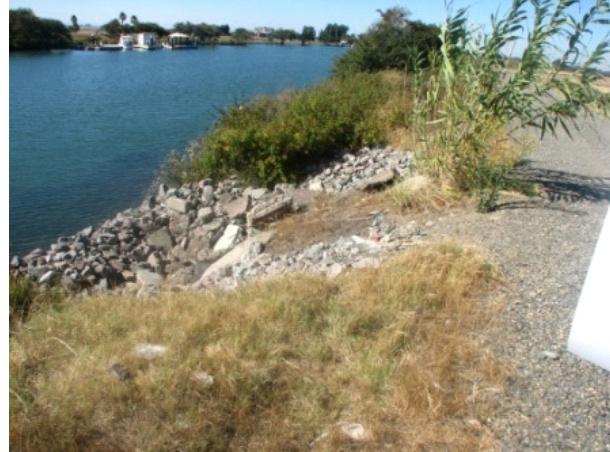
77	10.90	10.90	Earthen Levee	Slope Stability	WS	M	Repair slope instability. Inspector Comments: Site is not completely repaired			38.140307 ° 38.140307 ° 79 -121.596957 ° -121.596957 ° Y

Levee Mile Report Line	77
Start Levee Mile	10.90
End Levee Mile	10.90
Location	Water Side
Category	Earthen Levee
Item	Slope Stability
Uncompleted slope stability repair on waterside slope.	
richard_f_20100921_197.jpg

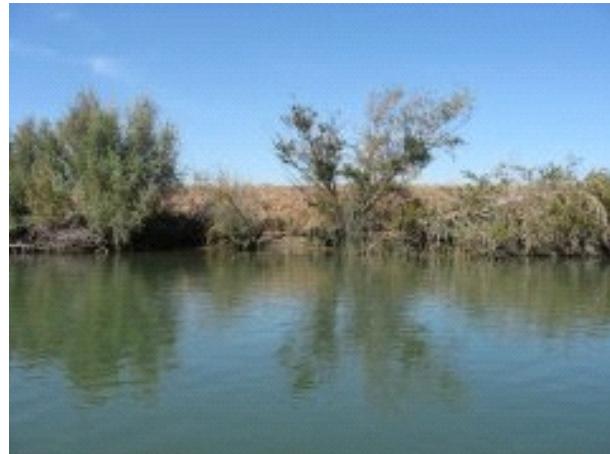
Levee Mile Report Line	79
Start Levee Mile	11.69
End Levee Mile	12.04
Location	Water Side
Category	Supplemental
Item	USACE Erosion Survey
2009: 5 ft berm, 1.5:1 slope, tree hazards and slumping, clays and silts, 4.63 ft/s [2009 SiteID:GEO_0-3_L]	
richard_f_20100921_196.JPG
